**RESEARCH  
REPORT  
NO.90-1**

# **Membrane and Flashing Condition Indexes for Built-Up Roofs Volume II: Inspection and Distress Manual**

**by  
Mohamed Y. Shahin  
David M. Bailey  
Donald E. Brotherson**

**Building Research Council, University of Illinois, Champaign, IL  
In cooperation with the US Army Corps of Engineers  
Construction Engineering Research Laboratory**

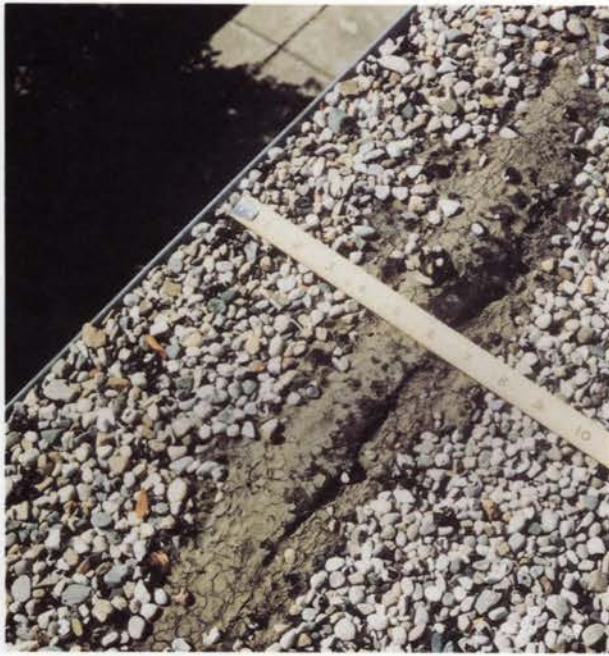
EM9 Embedded Edge Metal  
 <High Severity>  
 The stripping felt is torn along the back edge of the embedded metal

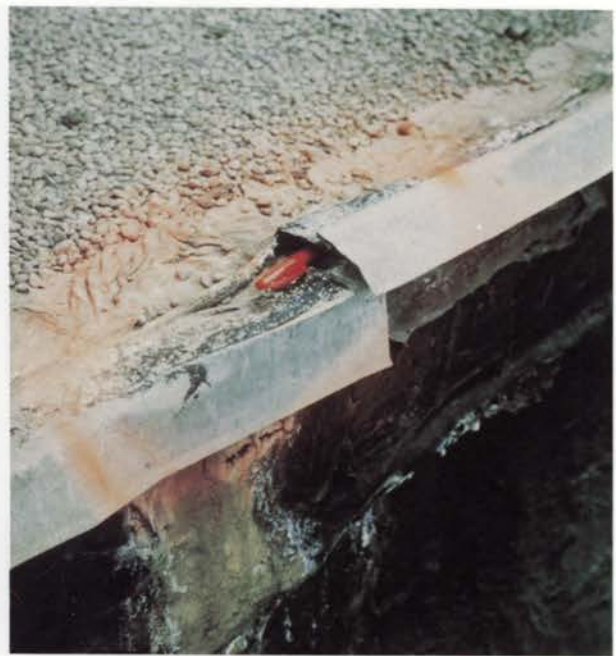
EM10 Embedded Edge Metal  
 <High Severity>  
 The edge metal is bent or deformed; the stripping is torn

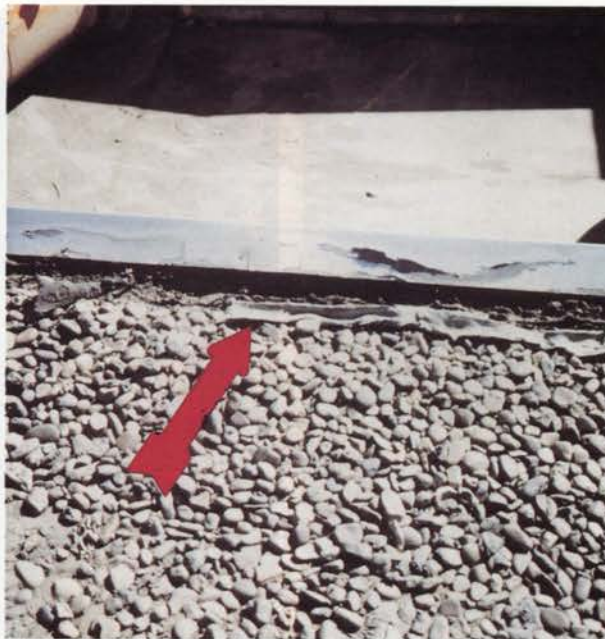
EM11 Embedded Edge Metal  
 <High Severity>  
 The stripping is torn

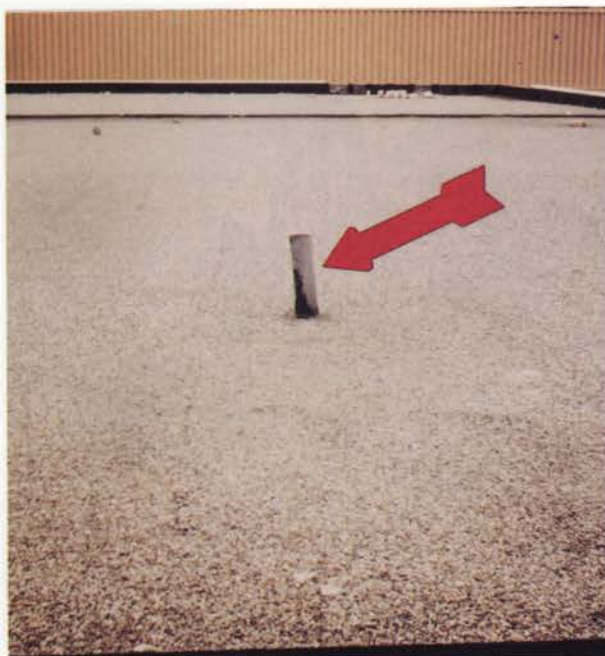
FP1 Flashed Penetration  
 <Low Severity>  
 The vent stack is distorted due to movement of the membrane

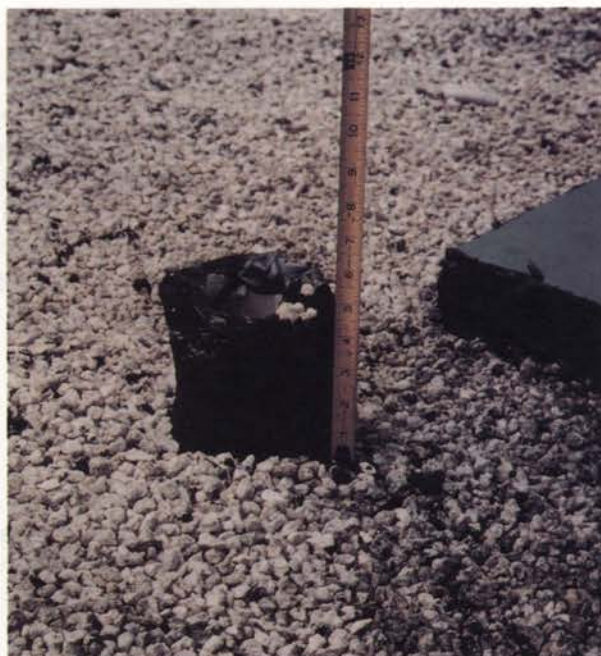
FP2 Flashed Penetration  
 <Low Severity>  
 The top of the flashing is less than 6 in. above the finished roof

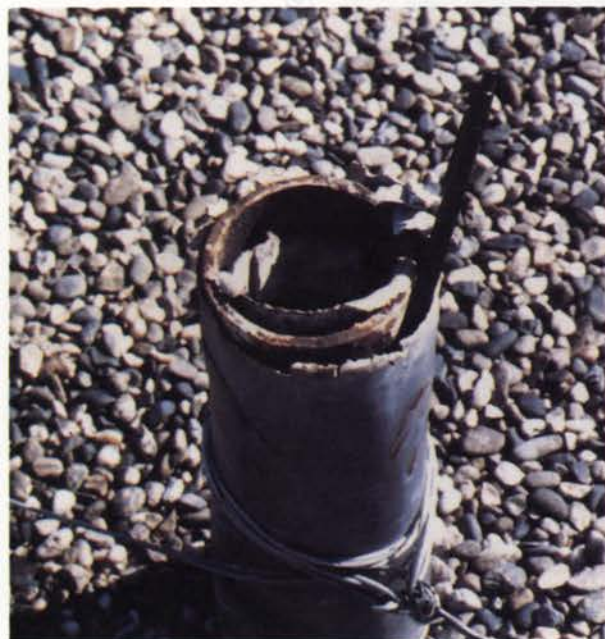
FP3 Flashed Penetration  
 <Low Severity>  
 The top of flashing sleeve is not sealed

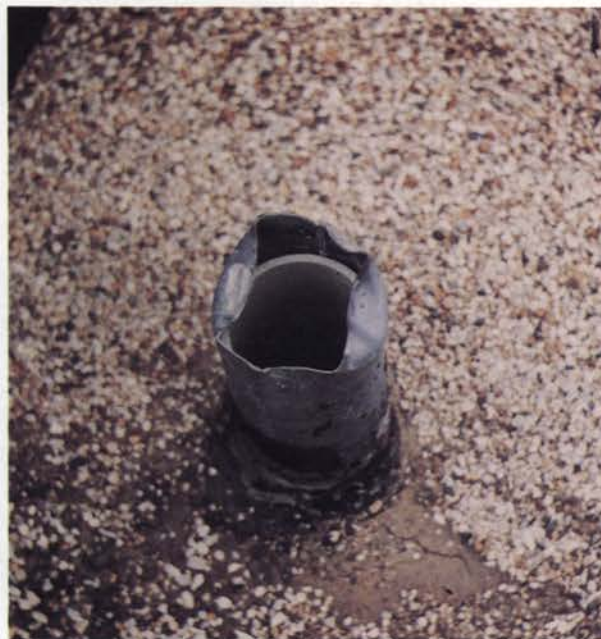
FP4 Flashed Penetration  
 <Medium Severity>  
 The lead had not been rolled down into the vent

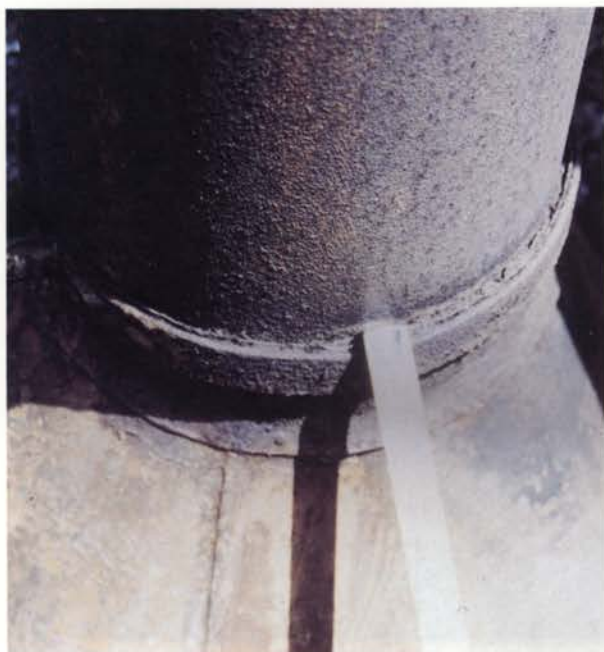
FP5 Flashed Penetration  
 <Medium Severity>  
 The seal at the umbrella is broken

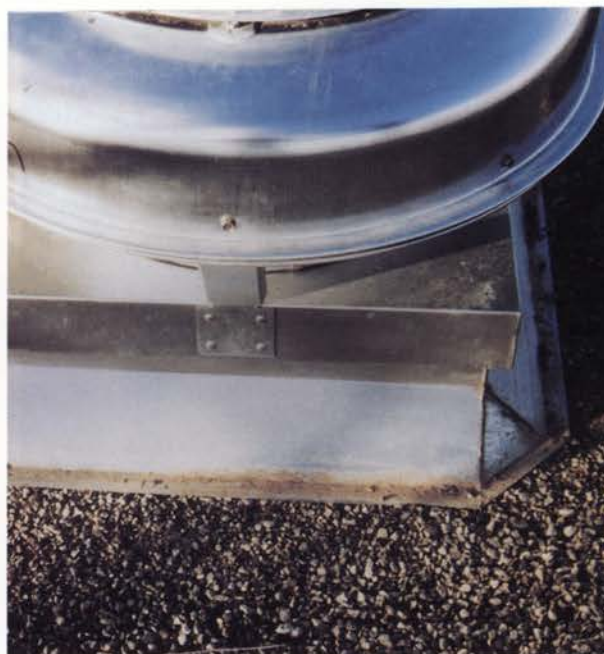
FP6 Flashed Penetration  
 <Medium Severity>  
 The flashing curb has not been  
 stripped-in

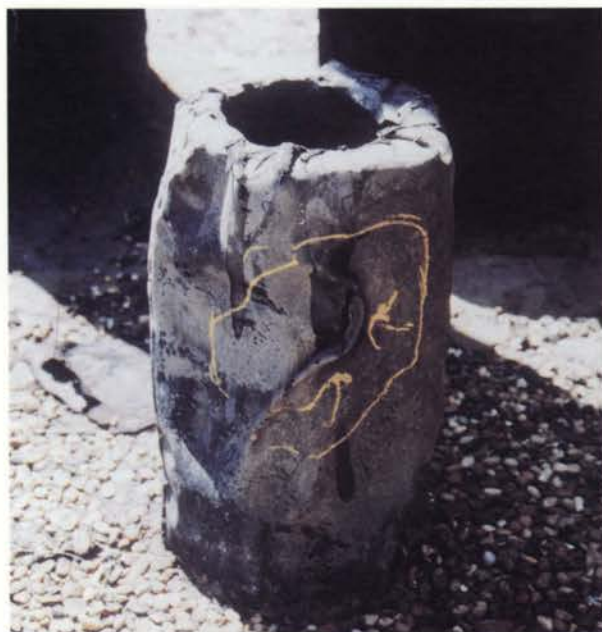
FP7 Flashed Penetration  
 <Medium Severity>  
 The flashing sleeve is cracked or  
 broken

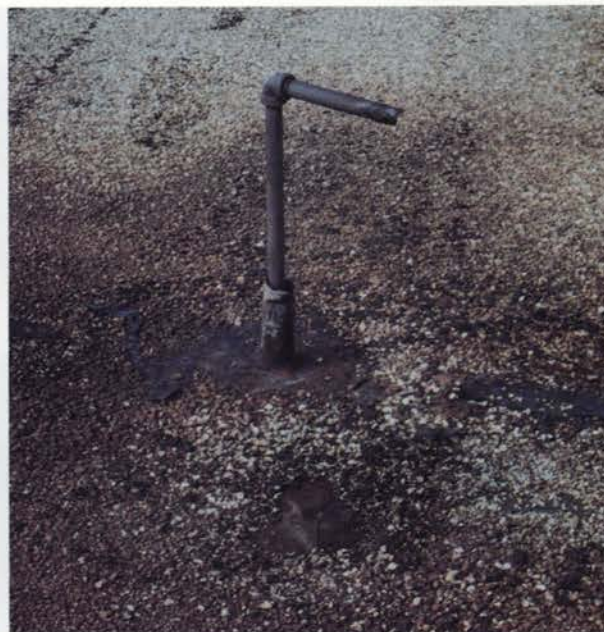
FP8 Flashed Penetration  
 <Medium Severity>  
 The flashing umbrella is missing

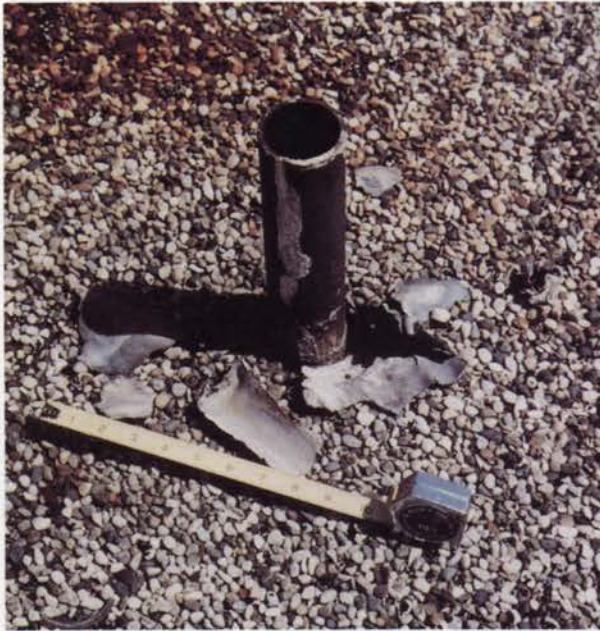
FP9 Flashed Penetration  
 <High Severity>  
 The lead flashing is broken

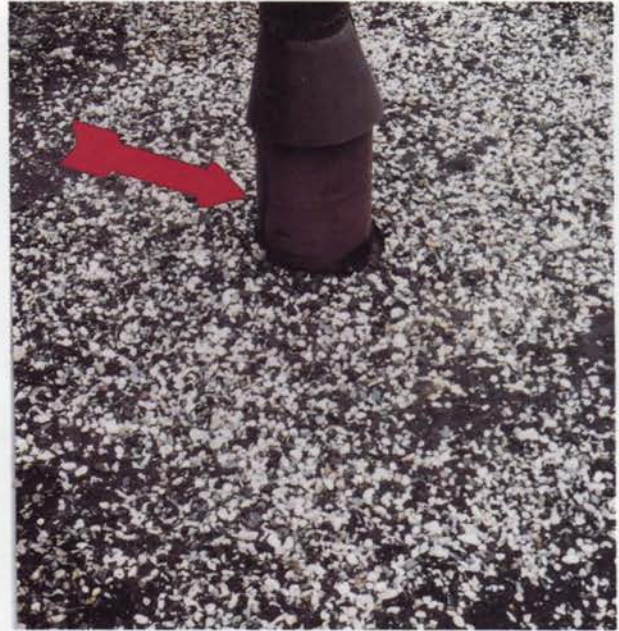
FP10 Flashed Penetration  
 <High Severity>  
 The joint in the metal sleeve has failed

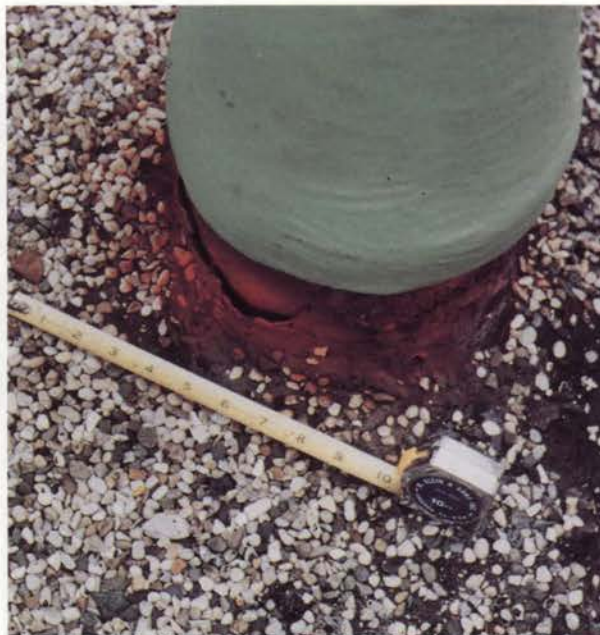
FP11 Flashed Penetration  
 <High Severity>  
 The metal has corroded and holes are evident

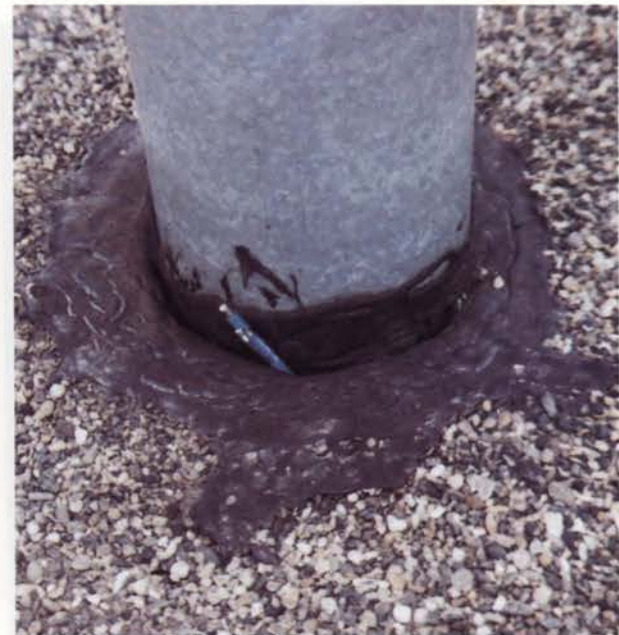
FP12 Flashed Penetration  
 <High Severity>  
 The metal flashing has been left out

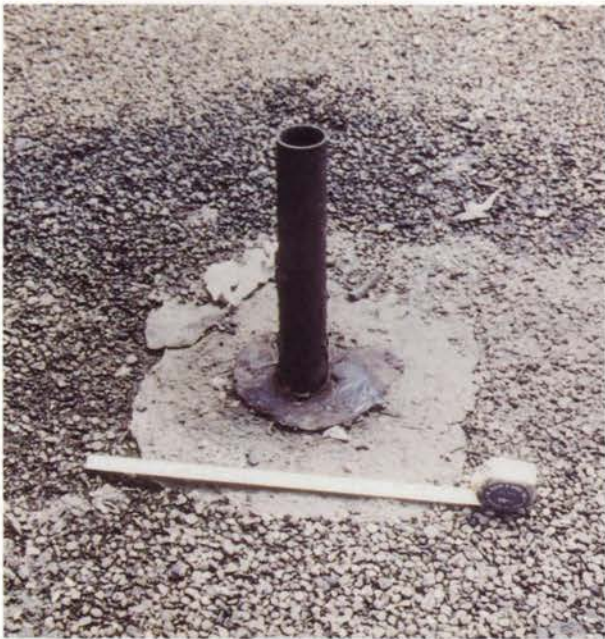
**FP13** Flashed Penetration  
 <High Severity>  
 Unflashed pipe penetration sealed  
 with roofing cement

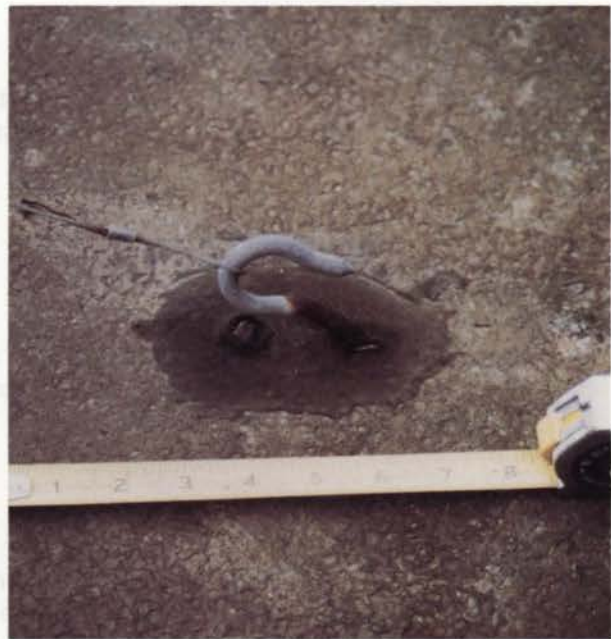
**FP14** Flashed Penetration  
 <High Severity>  
 Guy wire anchor has not been  
 flashed

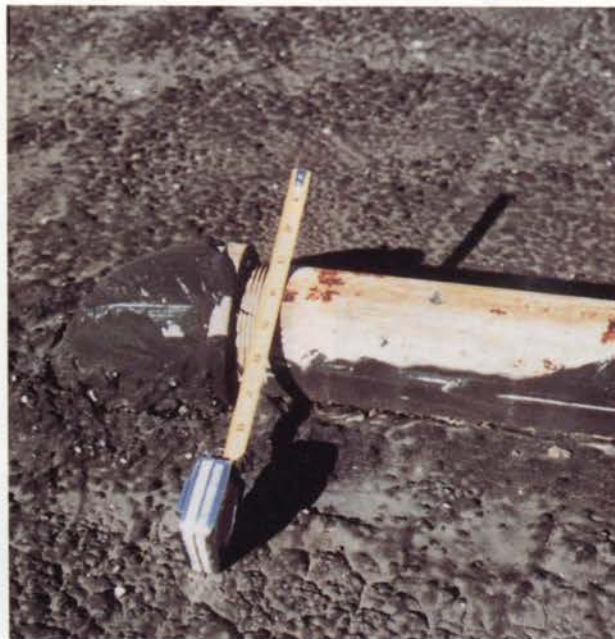
**FP15** Flashed Penetration  
 <High Severity>  
 The sleeve around the penetration is  
 missing; the conduit is lying on the  
 roof without supports

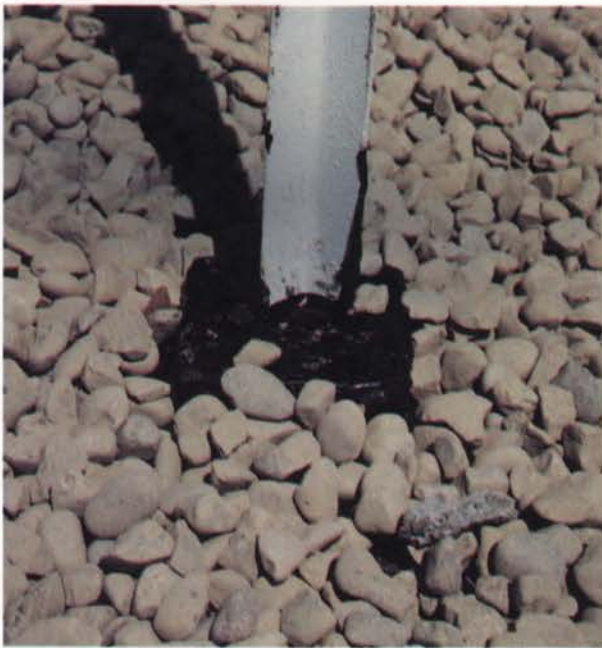
PP1 Pitch Pans  
<Low Severity>  
Pitch pan installed and maintained correctly but presents a hazard

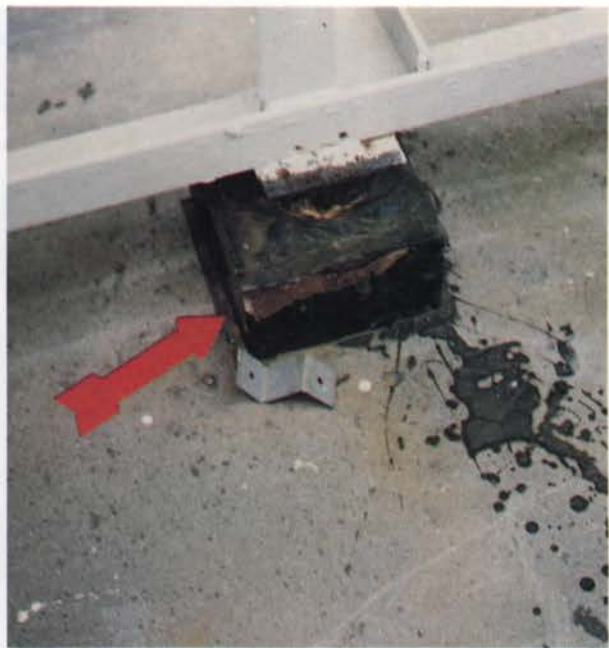
PP2 Pitch Pans  
<High Severity>  
Metal shows light corrosion

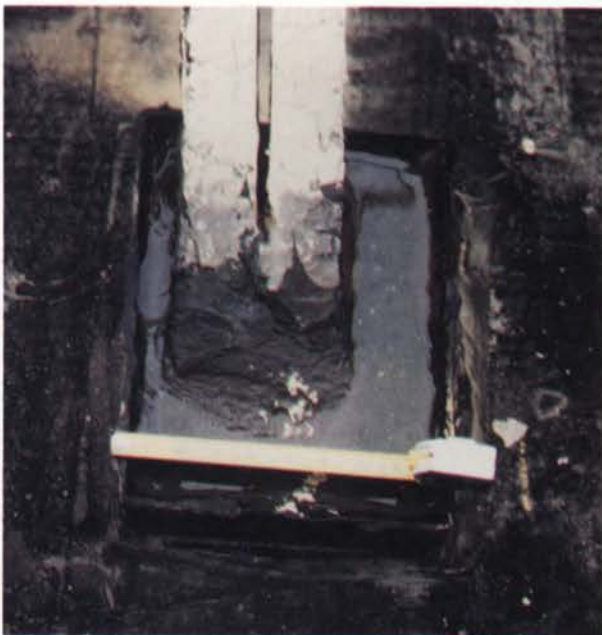
PP3 Pitch Pans  
<High Severity>  
Water standing in pitch pan; fill material not complete

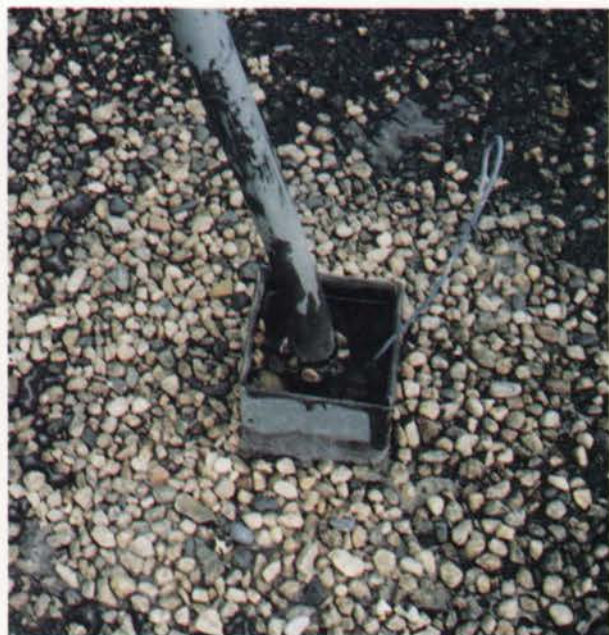
PP4 Pitch Pans  
<High Severity>  
Fill material is low; water standing in pan

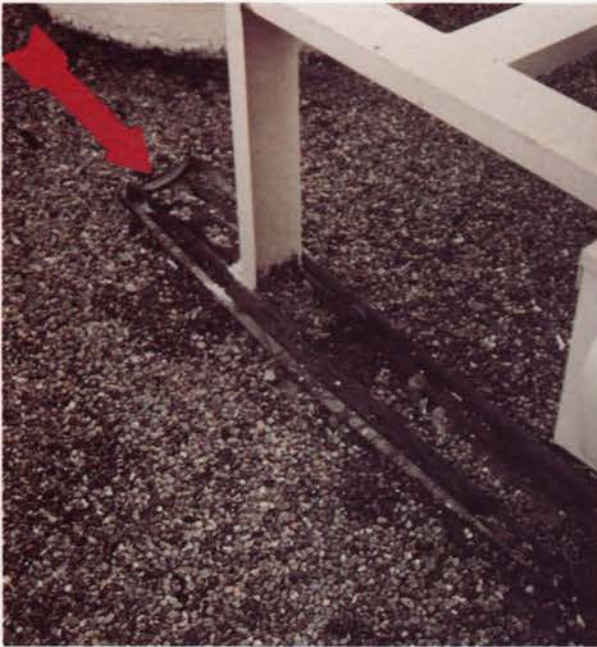
PP5 Pitch Pans  
 <High Severity>  
 Sides of pan are distorted; fill  
 material is low

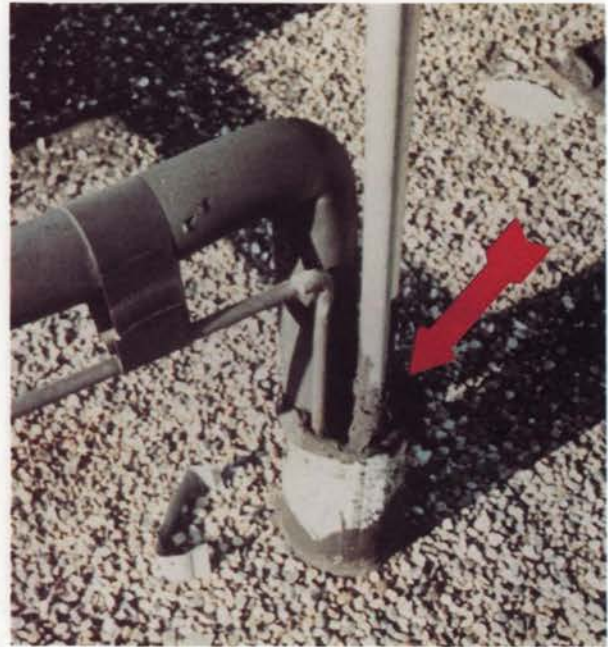
PP6 Pitch Pans  
 <High Severity>  
 Pipe sleeve used as pitch pan  
 has not been filled

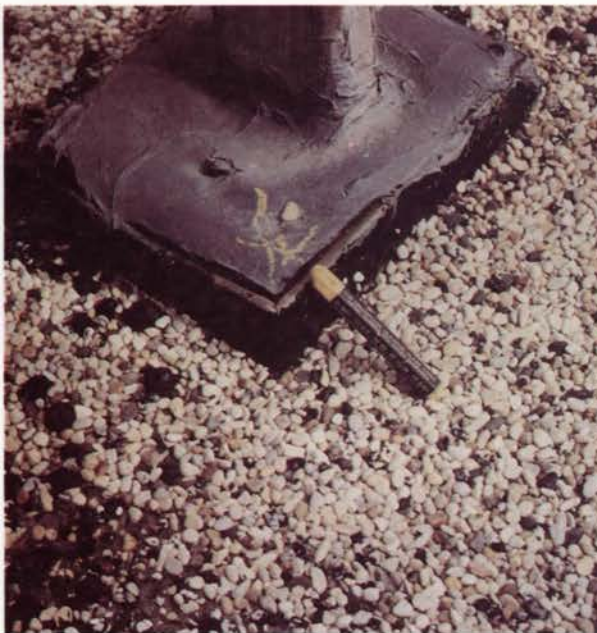
PP7 Pitch Pans  
 <High Severity>  
 Fill material has pulled away from  
 the sides of the pan

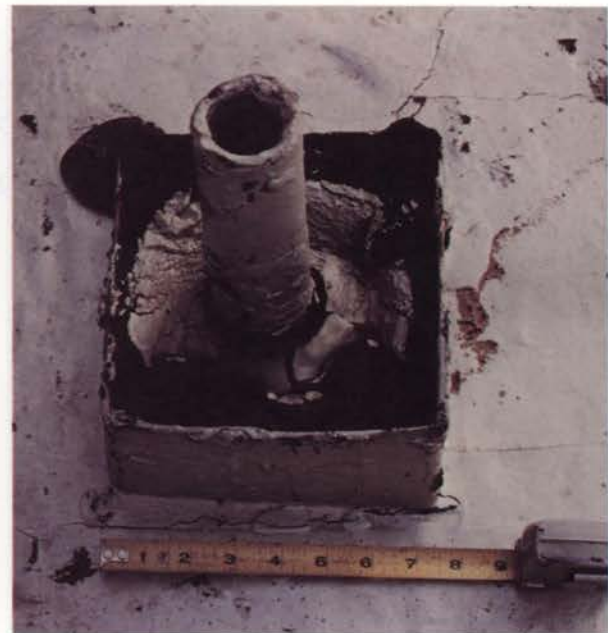
PP8 Pitch Pans  
 <High Severity>  
 Material has pulled away; water  
 can penetrate pan

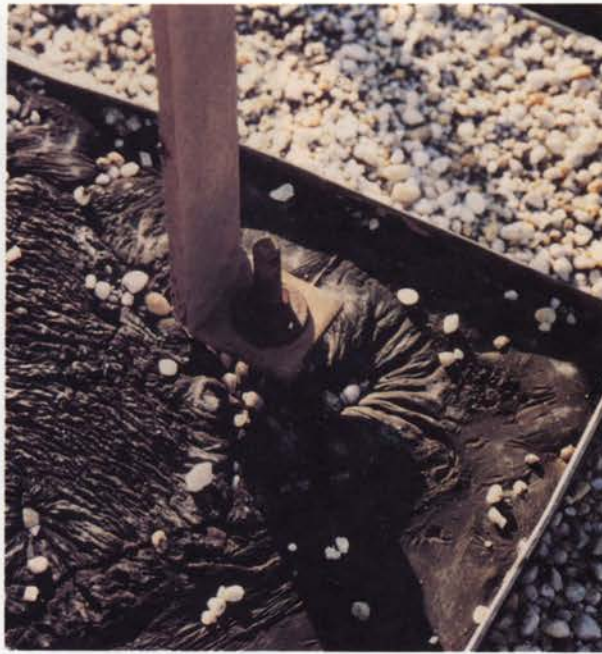
PP9 Pitch Pans  
<High Severity>  
Pan not full

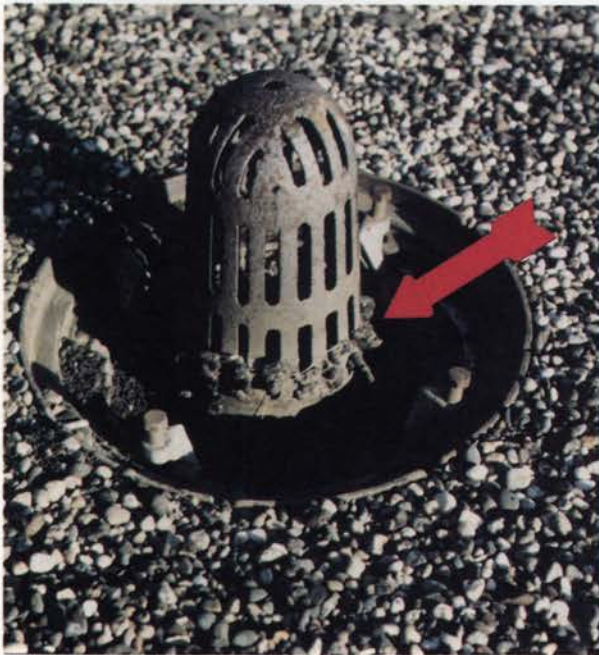
DR1 Drains and Scuppers  
 <Low Severity>  
 Bituminous material has flowed into the drain

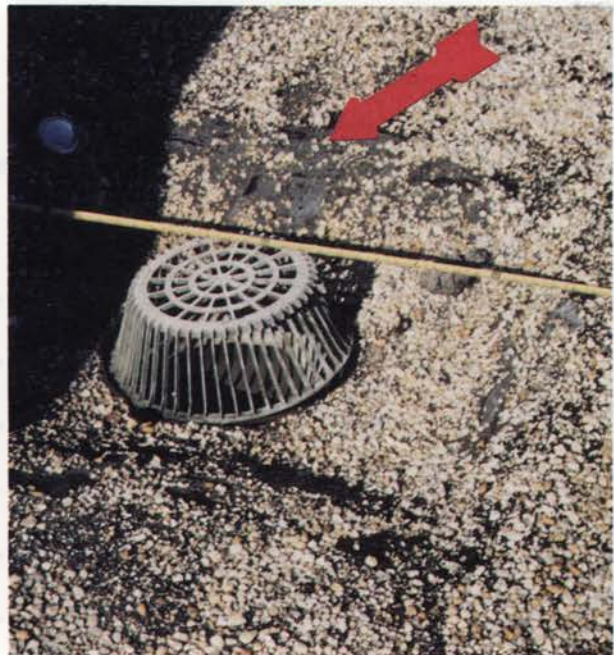
DR2 Drains and Scuppers  
 <Medium Severity>  
 The felts around the drain are exposed

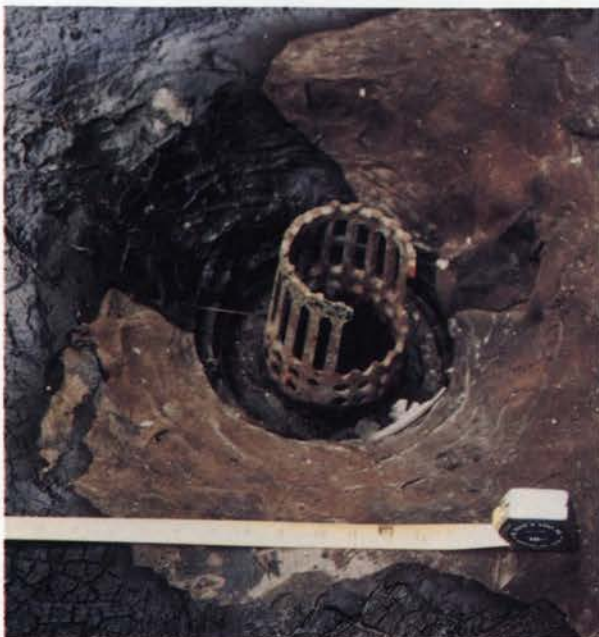
DR3 Drains and Scuppers  
 <Medium Severity>  
 The strainer is broken

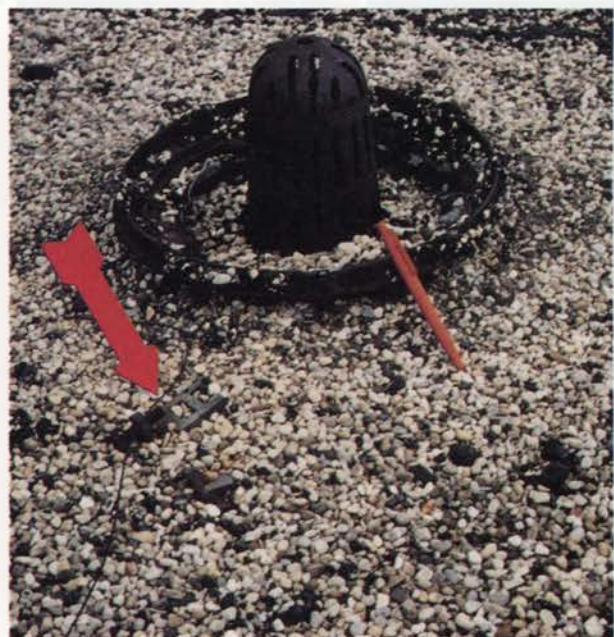
DR4 Drains and Scuppers  
 <High Severity>  
 The clamping ring is loose. Bolts are lying next to the ring

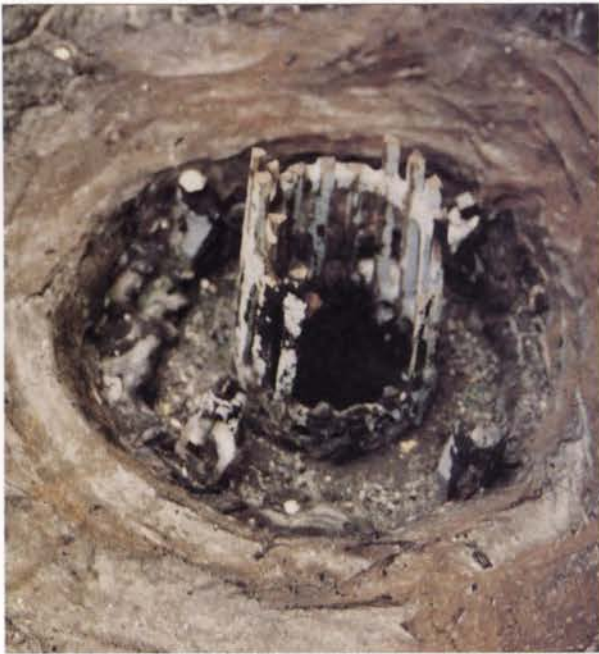
DR5 Drains and Scuppers  
 <High Severity>  
 The clamping ring is missing; also,  
 the strainer is broken and the drain  
 is clogged with bitumen

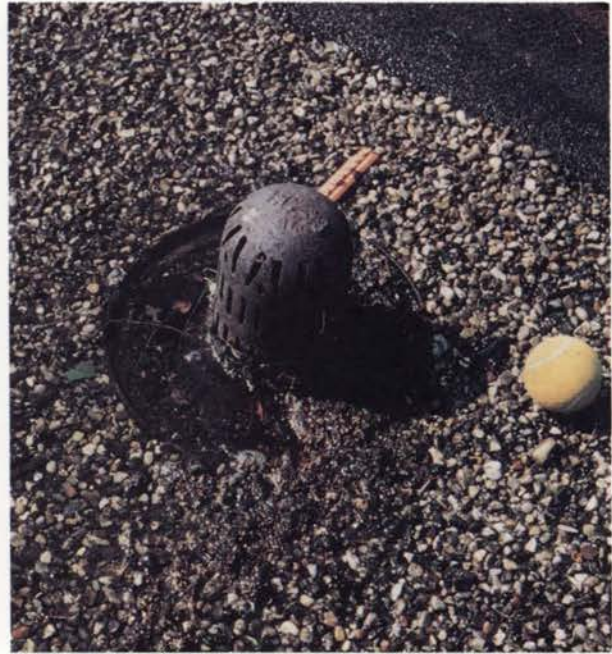
DR6 Drains and Scuppers  
 <High Severity>  
 The drain is clogged

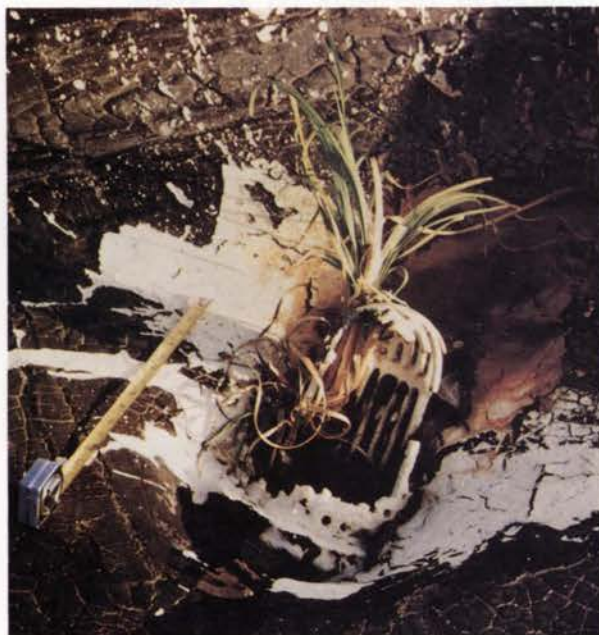
DR7 Drains and Scuppers  
 <High Severity>  
 The drain is clogged, the clamping ring  
 is missing, and the strainer is broken

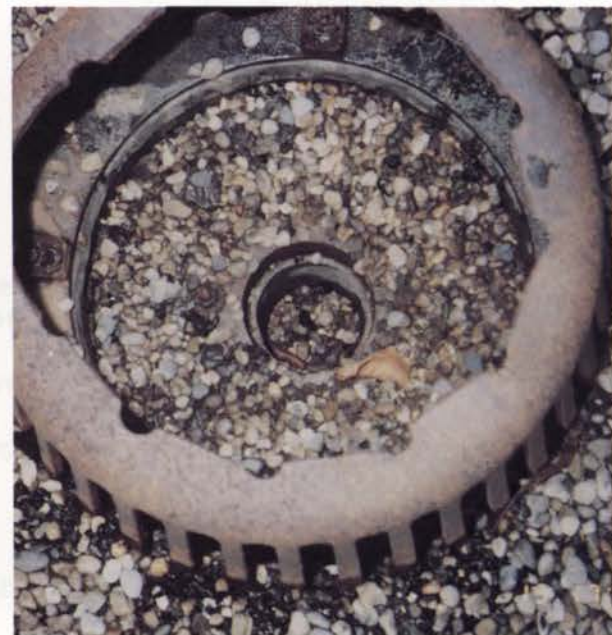
DR8 Drains and Scuppers  
 <High Severity>  
 The drain is clogged

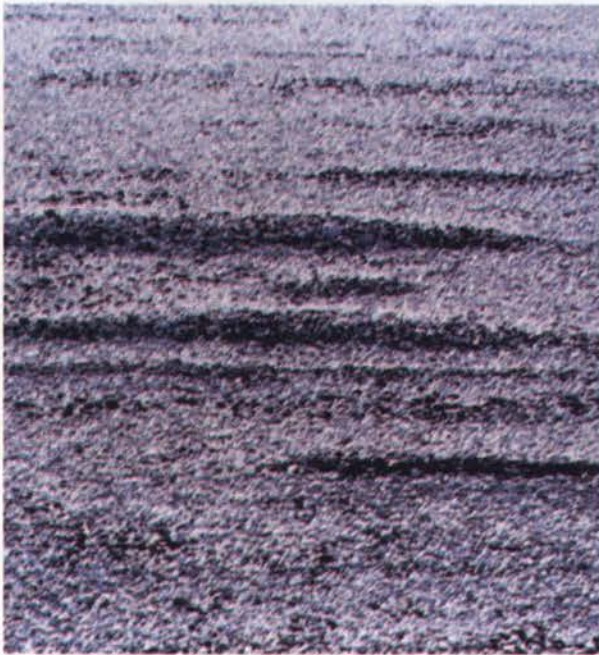
BL1 Blisters  
 <Low Severity>  
 Low severity blisters.  
 The surface is still in place

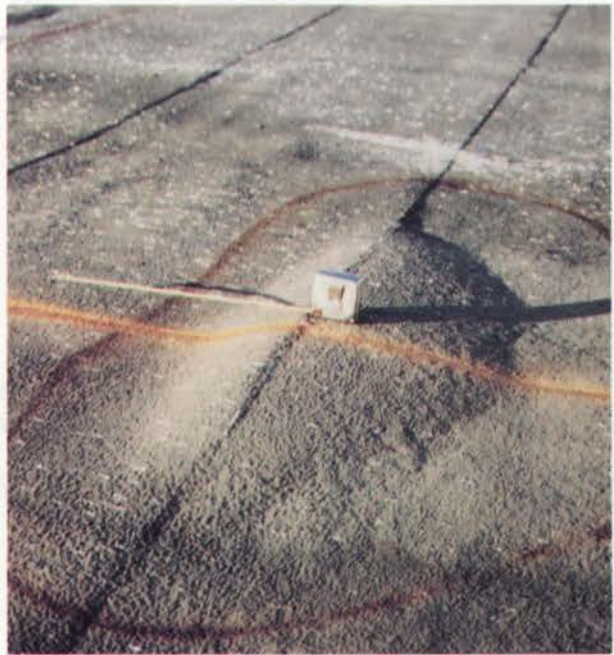
BL2 Blisters  
 <Low Severity>  
 Large blister but still low severity  
 level

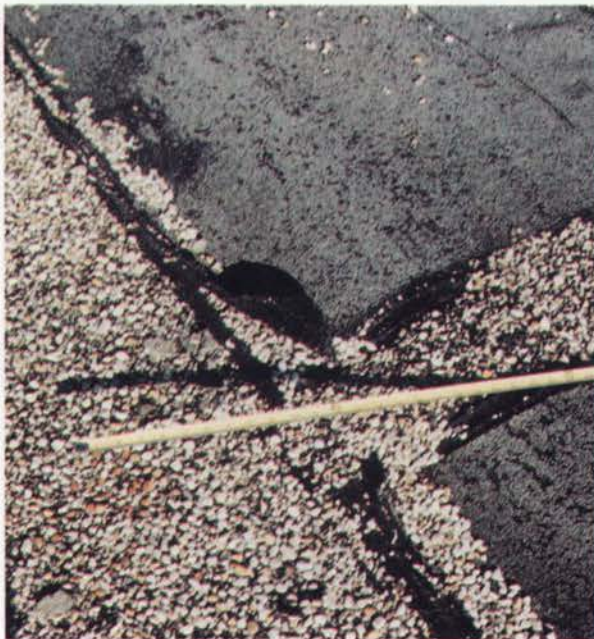
BL3 Blisters  
 <Low Severity>  
 Blisters in walk-pad application

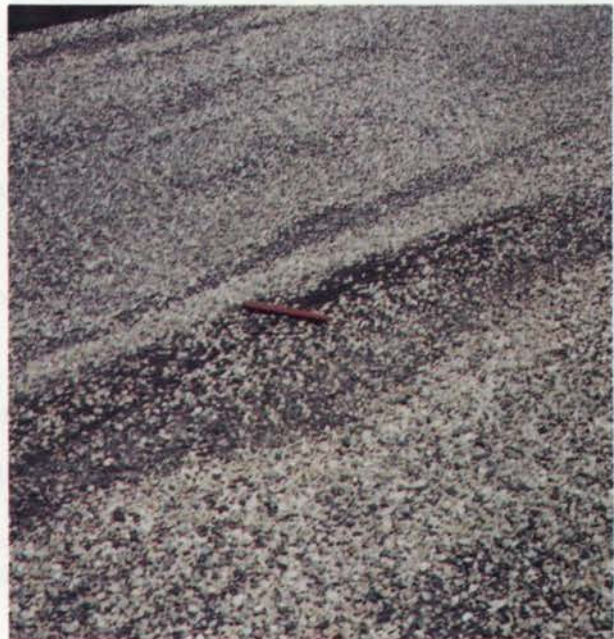
BL4 Blisters  
 <Low Severity>  
 Blisters in gravel surfaced  
 membrane

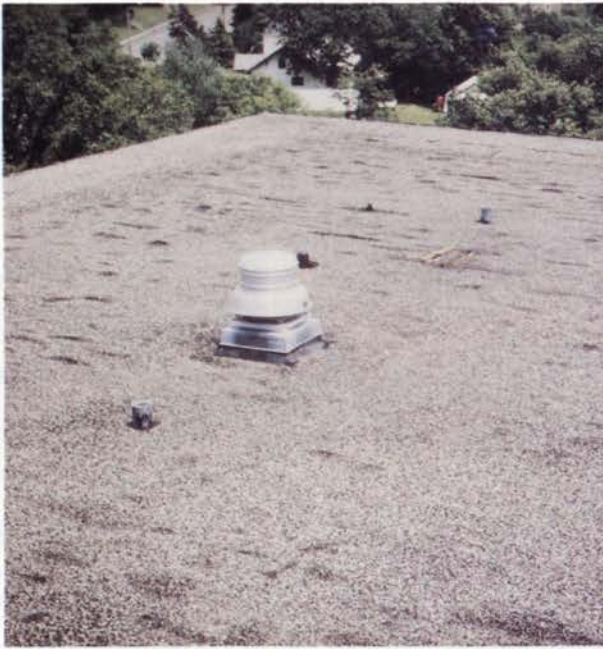
BL5 Blisters  
 <Low Severity>  
 General blistering over all of roof surface

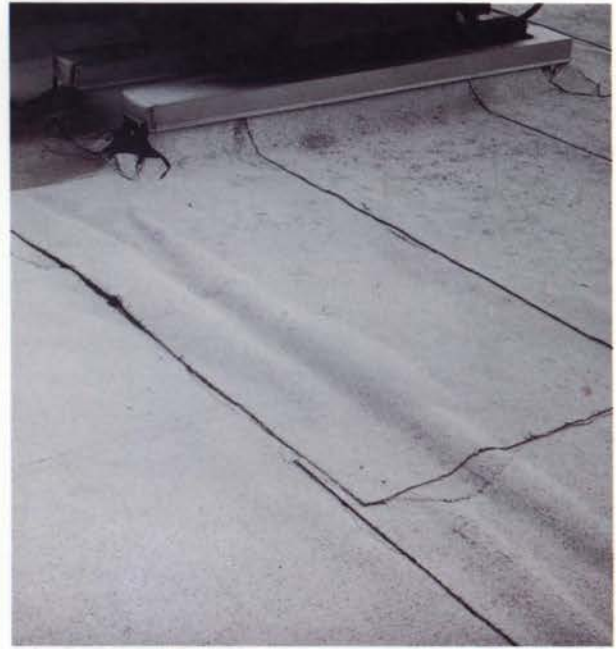
BL6 Blisters  
 <Low Severity>  
 Blisters in cap sheet

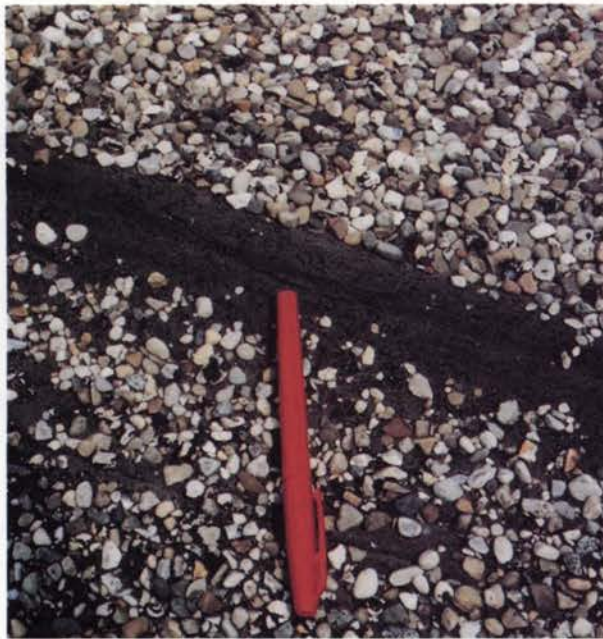
BL7 Blisters  
 <Medium Severity>  
 Blister is bare and felts are starting to show wear

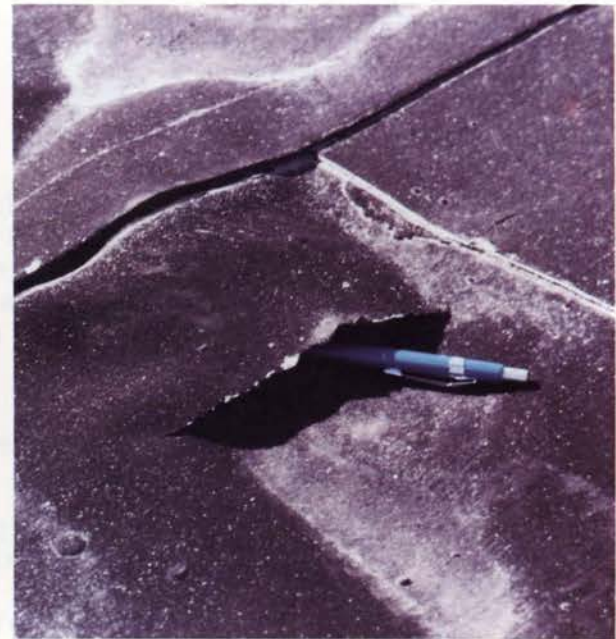
BL8 Blisters  
 <High Severity>  
 Blister has broken

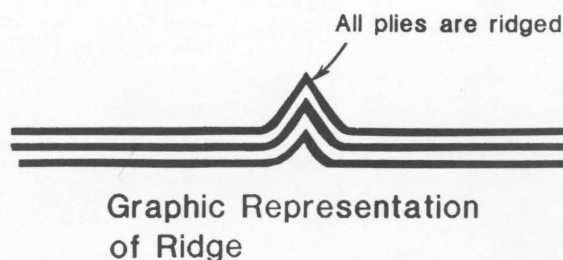
**Description:** Ridges are long, narrow (usually less than 3 in.), raised portions of the roof membrane. Their maximum height is about 2 in. Usually ridges occur directly above the insulation board joints and run perpendicular or parallel to the felts. They include all the plies and therefore are generally stiffer than blisters.

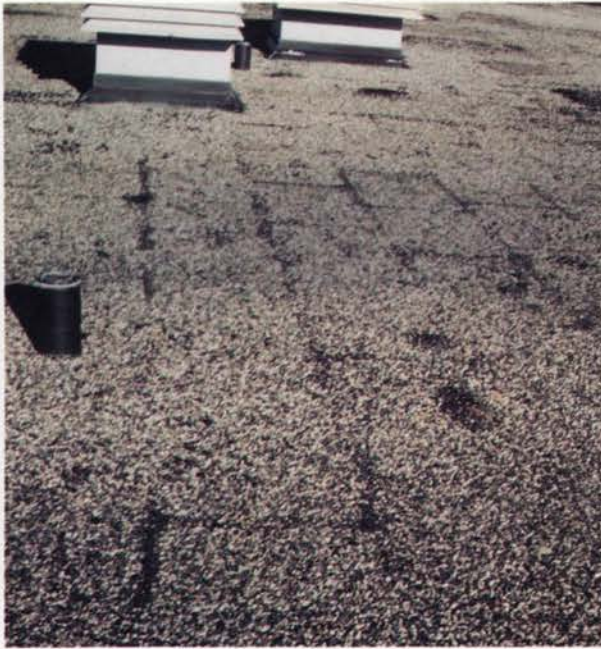
RG1 Ridges  
 <Low Severity>  
 Beginnings of ridges evident in surface; some picture framing evident

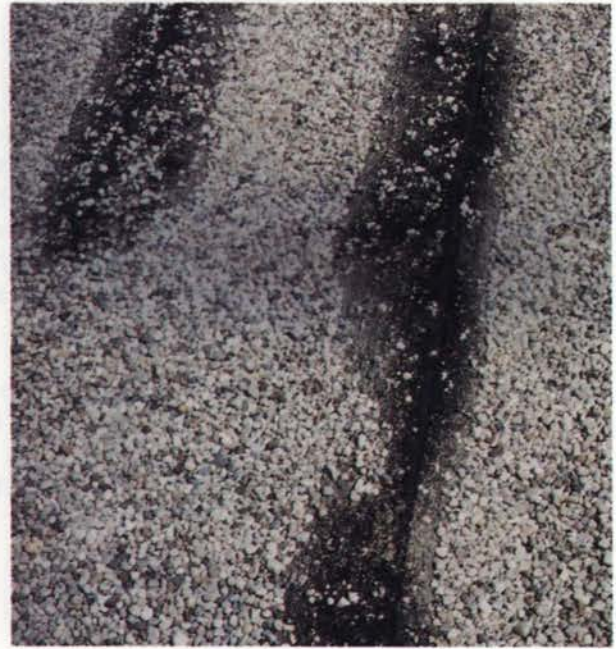
RG2 Ridges  
 <Medium Severity>  
 Closeup of medium severity ridging condition

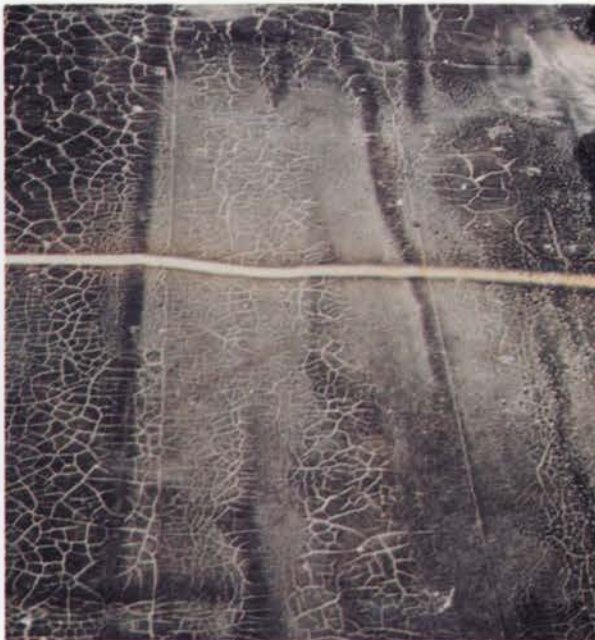
RG3 Ridges  
 <Low Severity>  
 Ridges in a smooth surface membrane

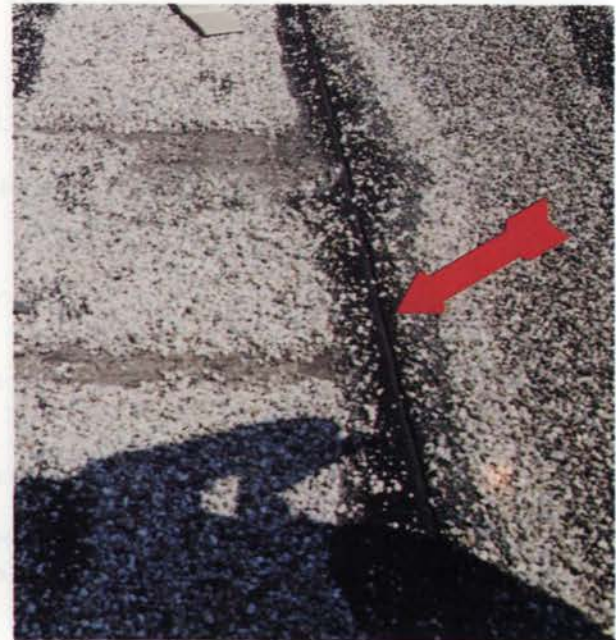
RG4 Ridges  
 <Medium Severity>  
 Bare felt showing; some slippage of felt at lap is evident

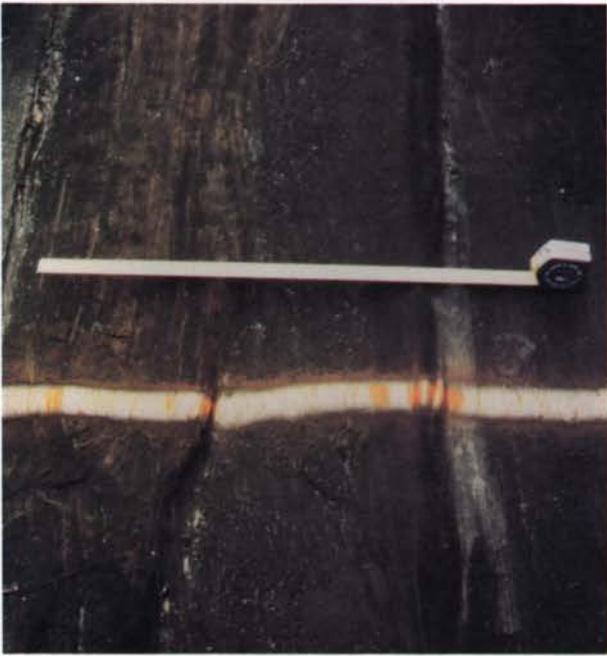
RG5 Ridges  
 <Medium Severity>  
 Smooth surface membrane

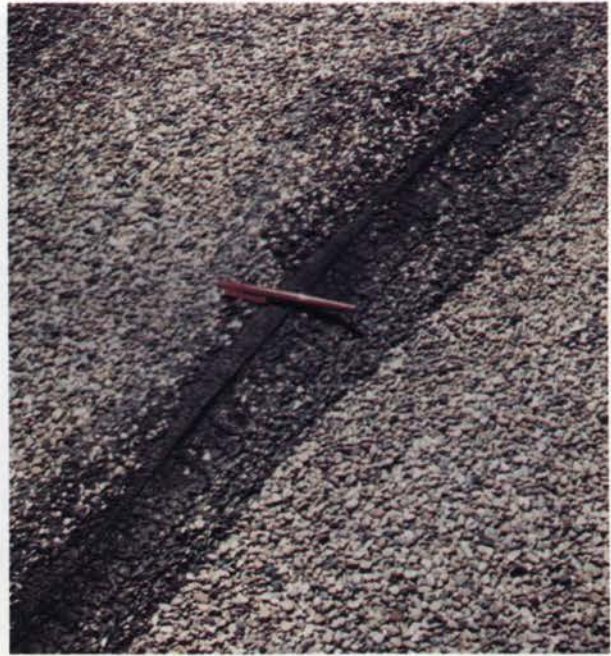
RG6 Ridges  
 <High Severity>  
 Felts are distorted; felt lap is opening up; first felt shows deterioration

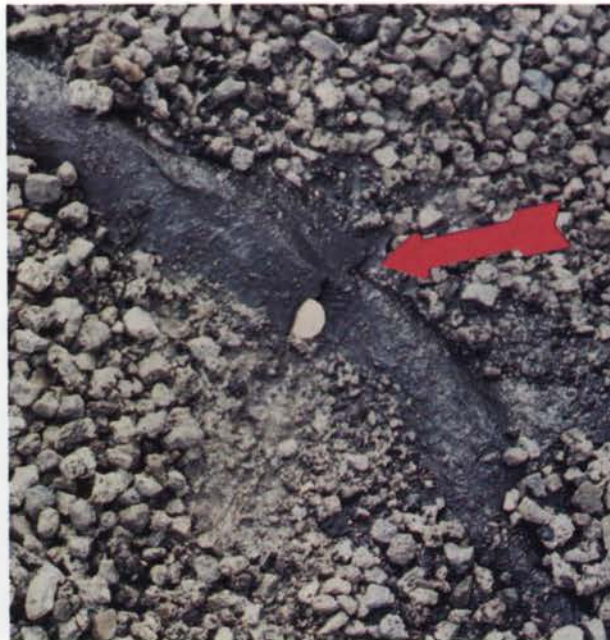
RG7 Ridges  
 <High Severity>  
 Ridge has collapsed; felt is broken or torn

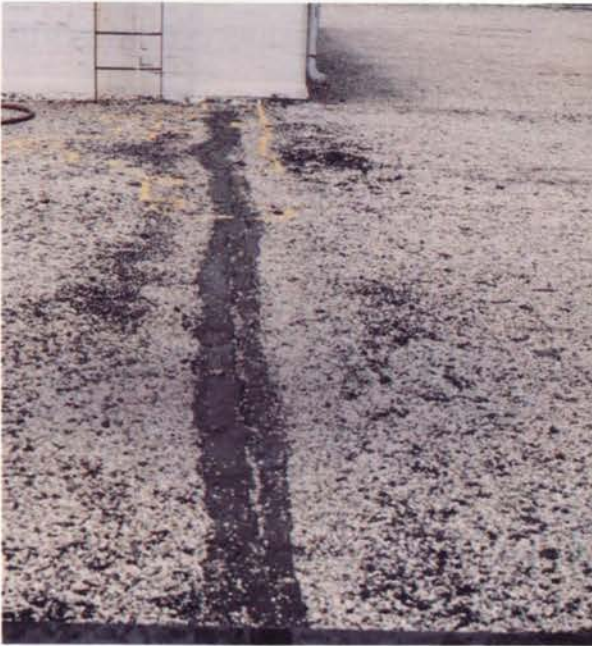
SP1 Splits  
<High Severity>  
Long split over structural member;  
yellow markings indicate water  
penetration determined by infrared  
(IR) scanning

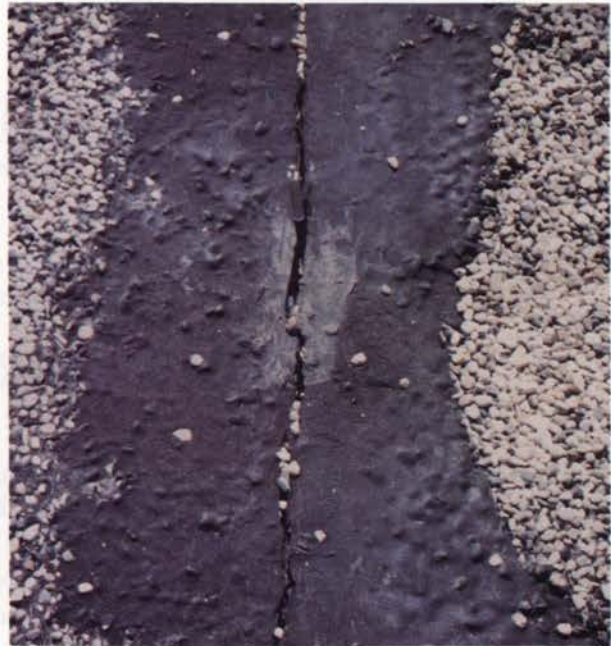
SP2 Splits  
<High Severity>  
Closeup of split in gravel surface;  
repair attempt made using mastic  
without reinforcing fabric

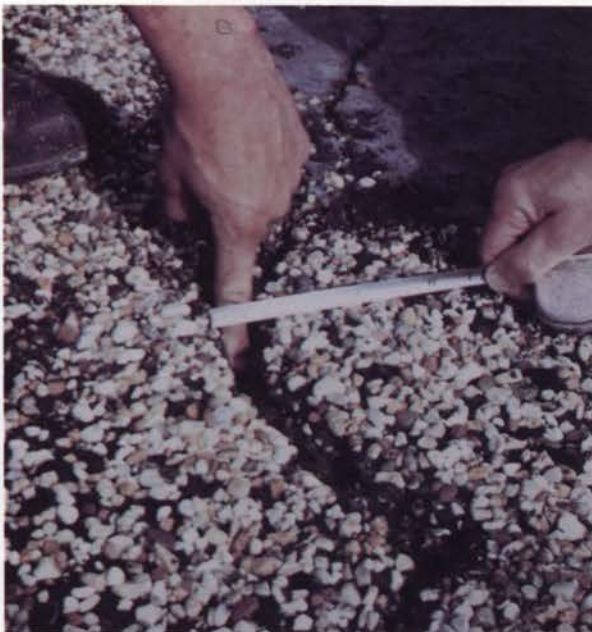
SP3 Splits  
<High Severity>  
Large split in gravel surface roof

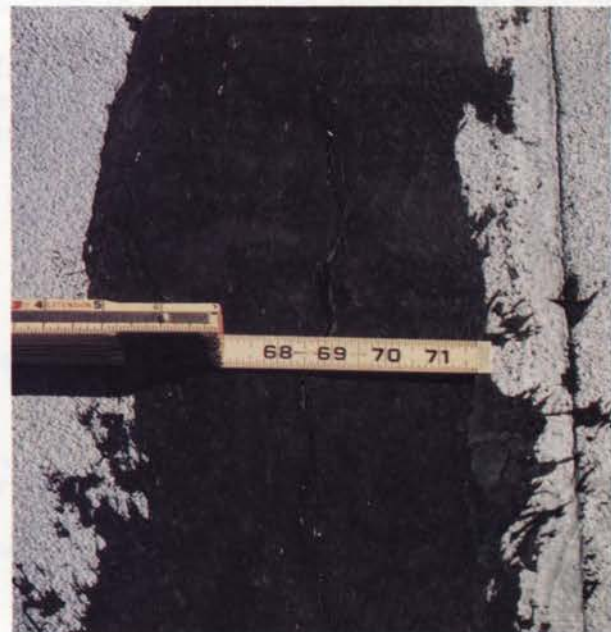
SP4 Splits  
<High Severity>  
Split in mineral cap sheet

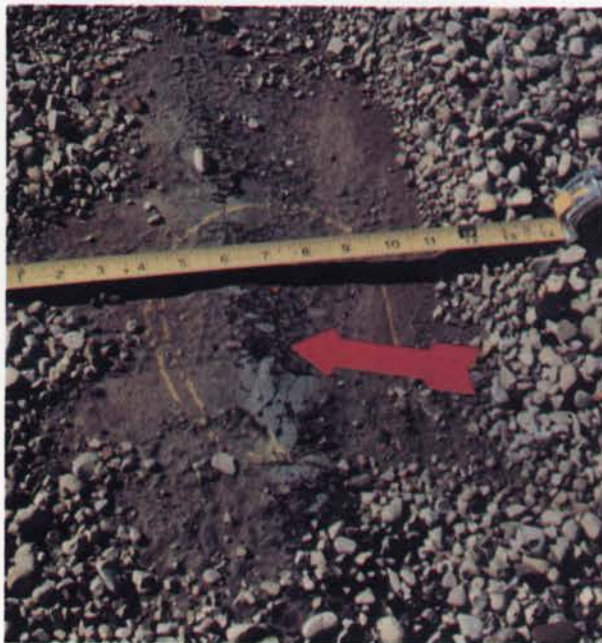
HL1 Holes  
<High Severity>  
Membrane below gravel surface has  
been penetrated by a sharp object
